Phase I Environmental Site Assessment

Greer Tracts - South Guadalupe

128 and 140 South Guadalupe Street

Terracon Project No. 96207001

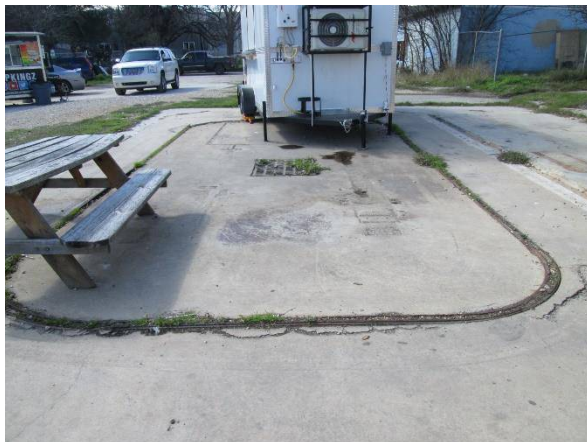
Photo 3 View of drain on the northern portion of the site

A drain was observed in the vicinity of the food trucks onsite (128 S. Guadalupe Street) at the time of the site reconnaissance. The drain appears to be associated with former automotive repair related operations at this location; either an inground lift or oil/water separator. Based on a review of historical aerial photographs, the former automotive detailing shop located north of the site (126 S. Guadalupe Street) extended on to this portion of the site and the feature observed onsite is likely associated with that facility. Please refer to Section 4.1 for further discussion of that facility (Detail Master).

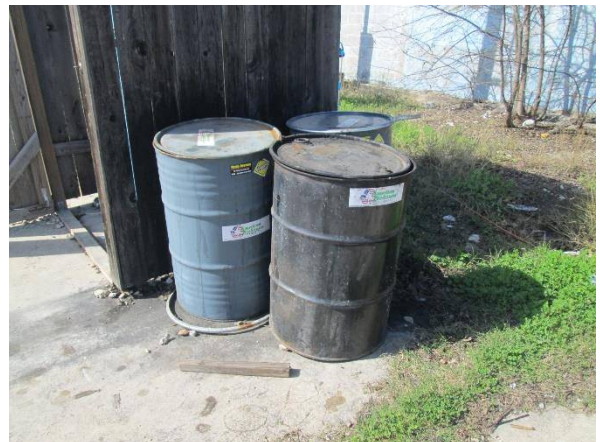
Photo 4 View of 55-gallon drums onsite

Three 55-gallon steel drums containing food waste were observed in the parking lot near the food trucks onsite. No evidence of a release, surficial staining, or noxious odors were observed in the vicinity of the drums at the time of the site reconnaissance. When no further use is intended, the drums and their contents should be removed and disposed of in accordance with applicable regulations.

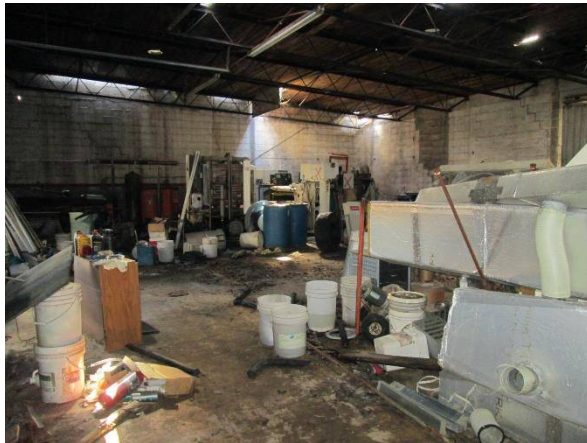
Photo 9 View of storage in the western portion of the building

Additionally, numerous 5-gallon open buckets of unknown liquid contents were observed throughout the western portion of the onsite building. None of the buckets appeared to be leaking at the time of the site reconnaissance. Ms. Greer was not aware of what the contents were of the buckets. The buckets and their contents should be characterized, removed, and disposed of in accordance with applicable regulations prior to site redevelopment.

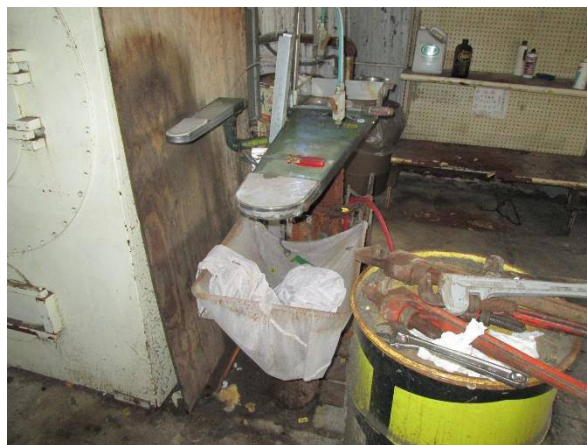
Photo 14 View of the laundry spotting table

chemicals were stored on open shelves that were observed during the site reconnaissance and staining was observed beneath the shelves. According to Ms. Greer, the spot treatment chemicals were applied to garments on the laundry spotting table adjacent to the dry-cleaning machines and the garment was steamed and vacuumed before placing in the dry-cleaning machine. Ms. Greer was not aware of where or how the vacuumed product was disposed. Based on the duration of operations (~30 years) and observations made during the site reconnaissance, the former onsite dry-cleaning operations appear to constitute a REC in connection with the site.

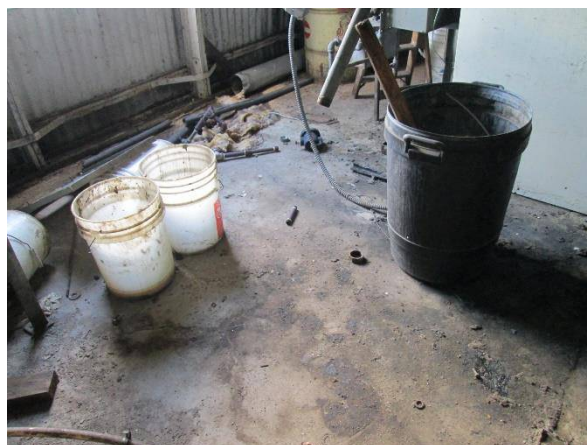
Photo 16 View of stains and releases from the dry cleaning and reclaiming dryer machine

Concrete staining was observed in the vicinity of the dry-cleaning machines in the former Comet Cleaners at the time of the site reconnaissance. No evidence of floor drains were observed in the vicinity of the dry cleaning machines. Please refer above to Dry cleaning and Section 3.6 for further discussion of the former dry-cleaning operations onsite.

Based on the scope of services, limitations, and findings of this assessment, Terracon recommends additional subsurface investigation to evaluate whether potential releases from the above referenced RECs have impacted environmental media (including soil, groundwater, and vapor) on the site.

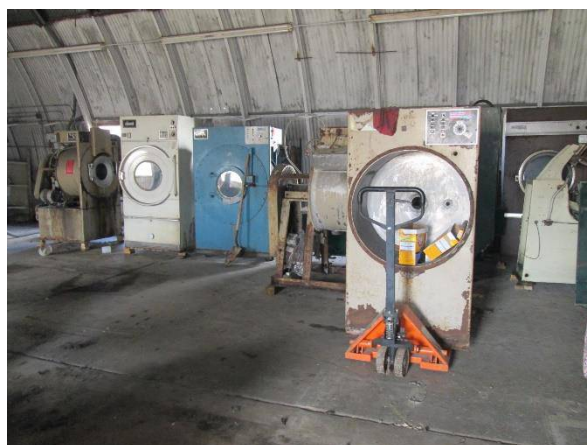
Photo 18 View of non-operating washing machines and dryers

An interior floor drain was observed in the Comet Cleaners building at the time of the site reconnaissance and, according to Ms. Greer, the washing machines discharge to the drain and it discharges to the sanitary sewer system. Additionally, the city inspected and took samples from the drain once a year and they had been compliant since operations began according to Ms. Greer. Evidence of staining or other releases to the floor drain was not observed during the site reconnaissance. Potentially hazardous materials did not appear to be stored in the vicinity of the floor drain.

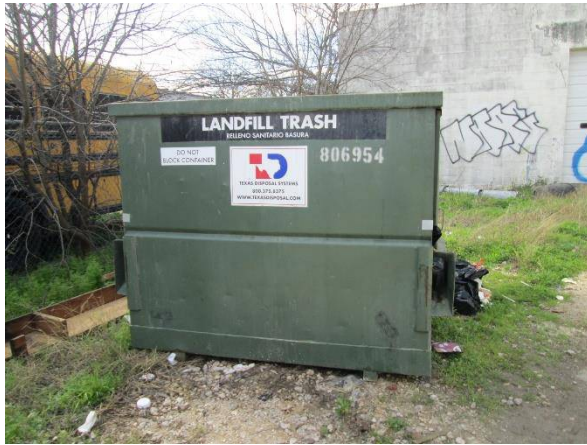
Photo 19 View of solid waste disposal dumpster onsite

One solid waste disposal dumpster (serviced by Texas Disposal Systems) was observed on the southern portion of the site. No evidence of staining, noxious odors or hazardous waste disposal

was observed within or in the vicinity of the onsite dumpster at the time of the site reconnaissance.
